# American Property Inspections of Texas

## PROPERTY INSPECTION REPORT

Concerning: 1234 Sample Court Anytown, TX.

**August 3, 2010**

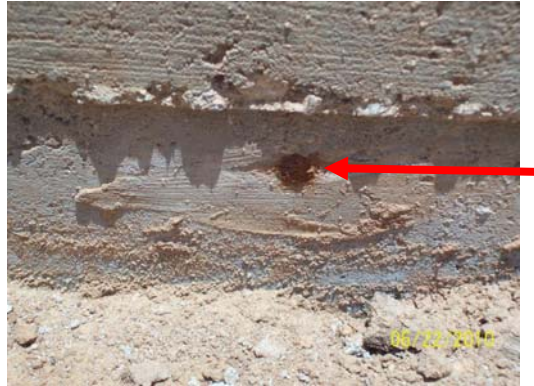
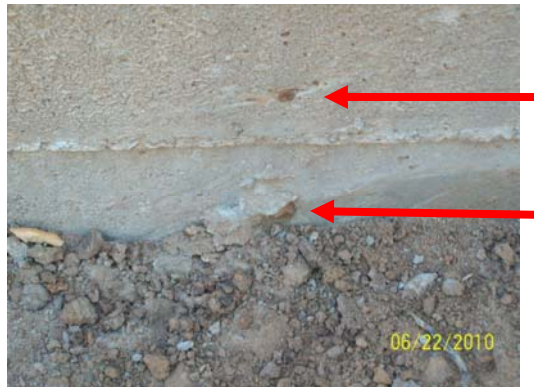
Exposed rebar/tendon ports on the west side of the structure.

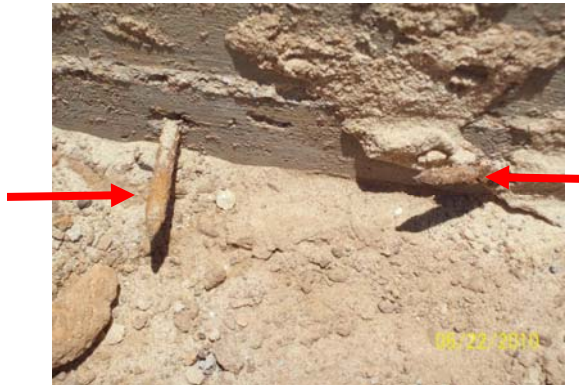
Nails protruding from foundation wall on the west side of the structure.

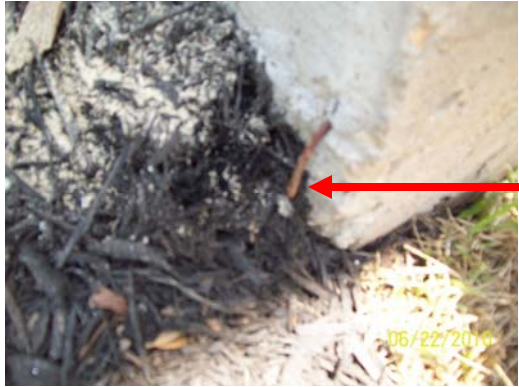
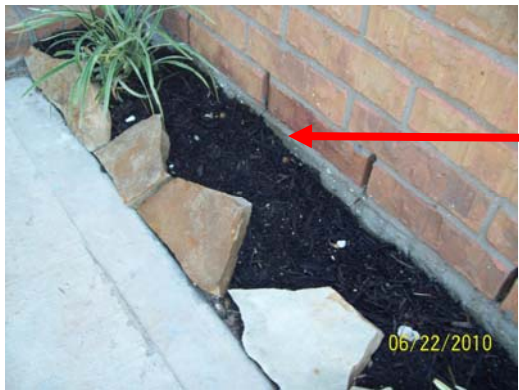
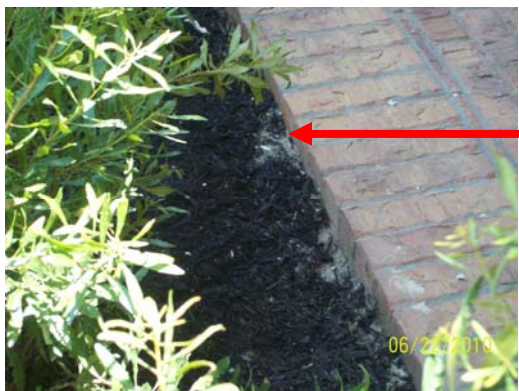
There were areas around the structure that were not accessible due to grade not having the minimum 4" - 6" clearance as required.

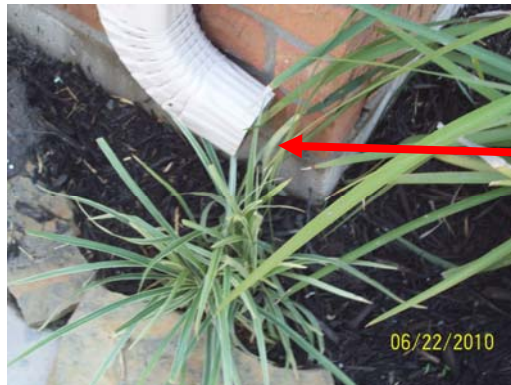
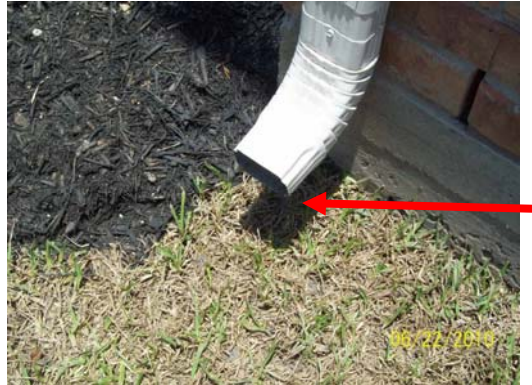
Gutter down spouts do not divert water from foundation properly, down spouts should divert water away approximately 5' from foundation.

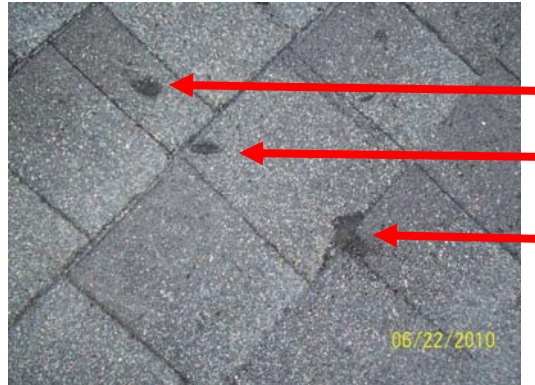
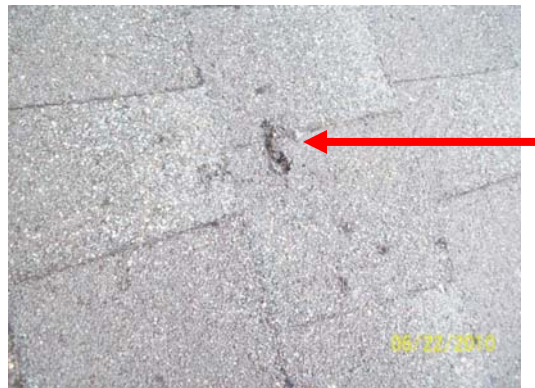
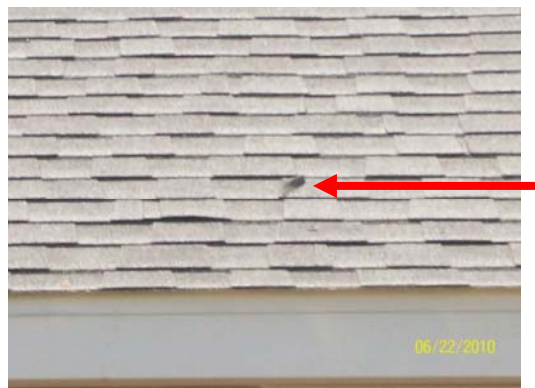
Roof showed signs damaged shingles over front and back porches and on east side of structure.

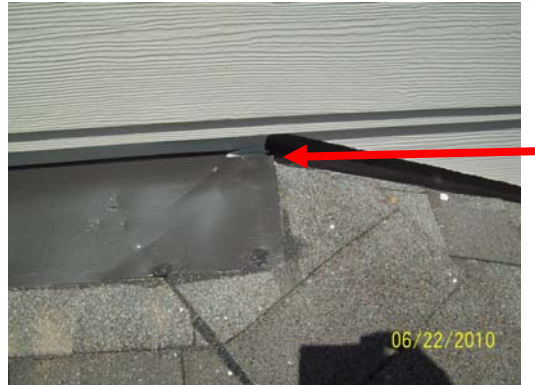
Flashing on the southeast side of the back porch appeared to be improperly installed and may allow water penetration.

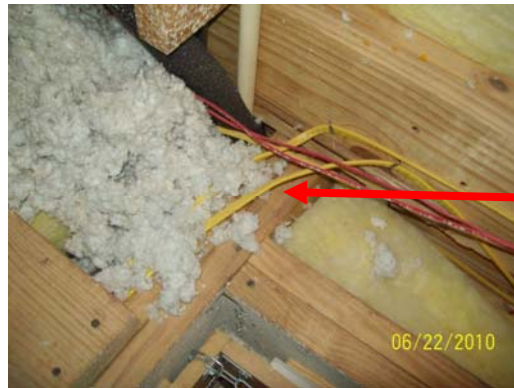
Electrical conductors not protected within 6' of attic opening.

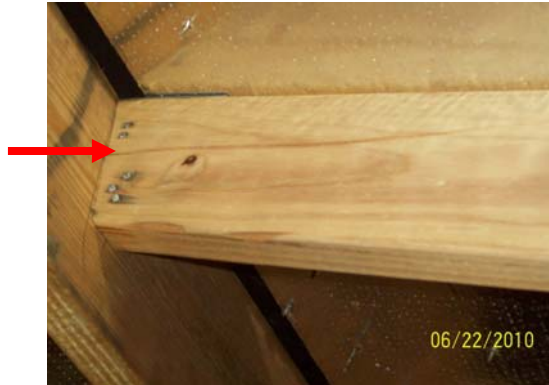
Cracked rafter at ridge beam between the water heaters and the air handler.

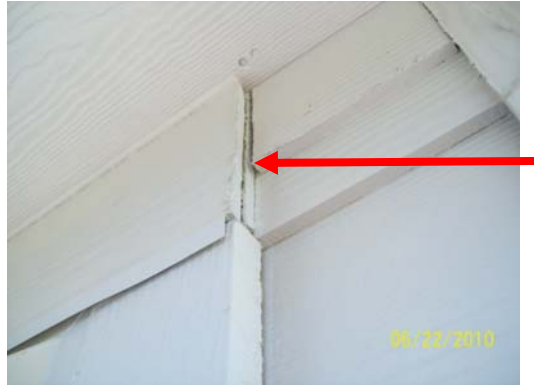
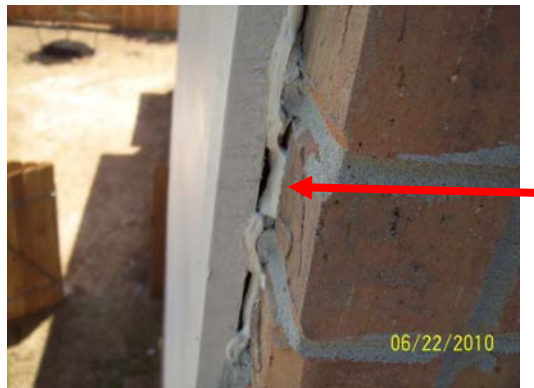
Caulking/sealant missing from siding/trim at various locations around structure.

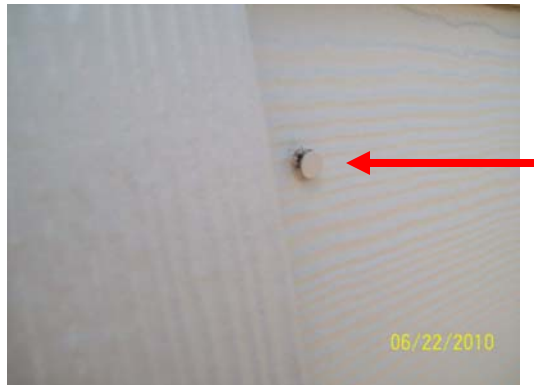
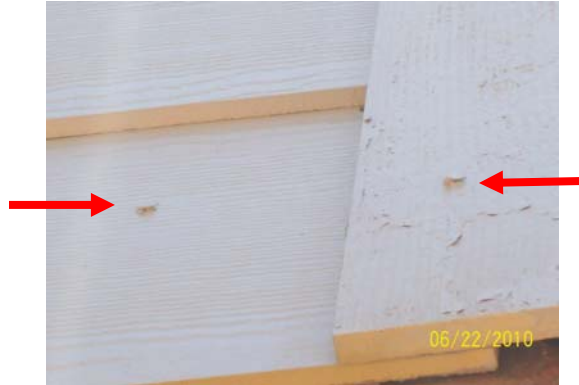
Nails not completely driven at various locations around structure.

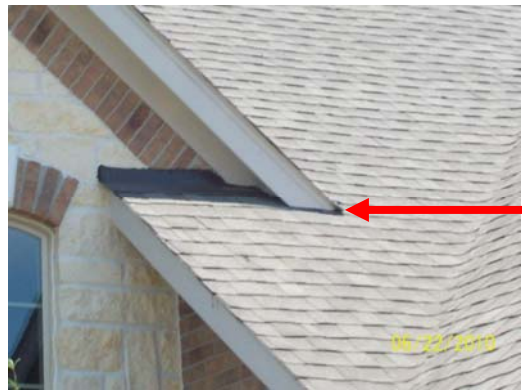
Exterior walls should be cut back a minimum of 2" where the wall meets the roof line.

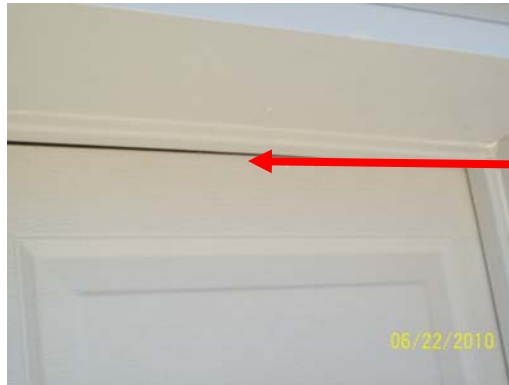
Garage doors were difficult to lock and did not appear to be plumb due to the gaps at that were observed at the header from the exterior when to doors were closed.

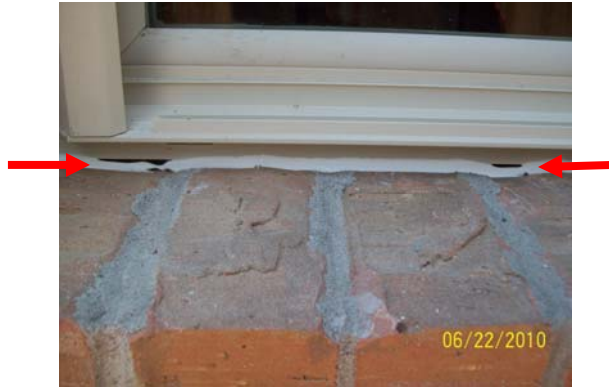
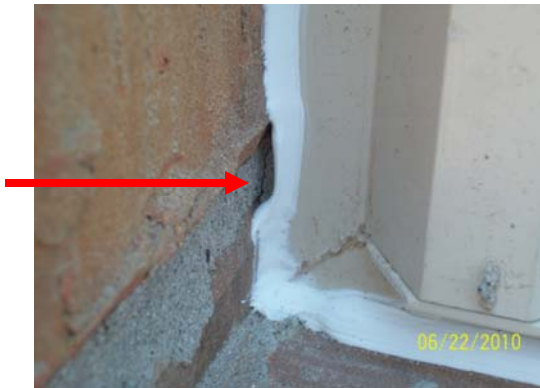
Various windows need to be caulked.

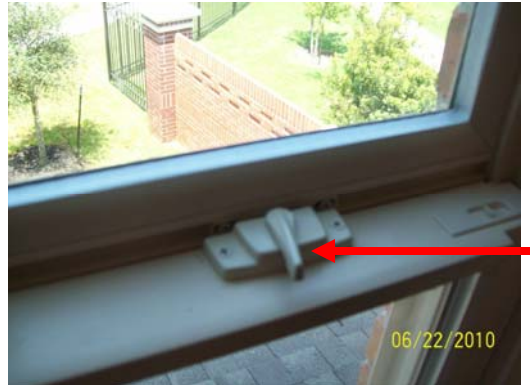
Window lock in the northeast upstairs bedroom on the east side would not latch completely.

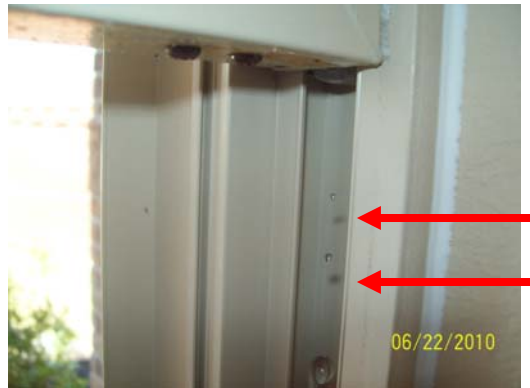
Water was leaking from window in the dining room on the east side when opened.

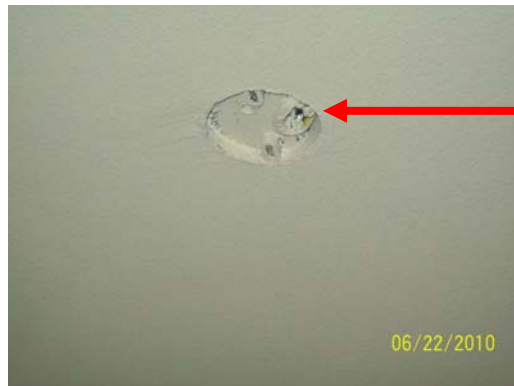
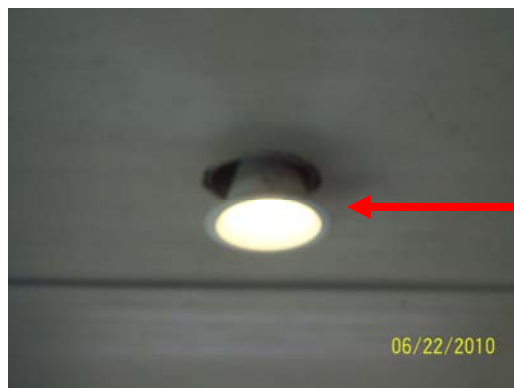
Stairwell light fixture was not installed.. The front exterior light was not properly installed.

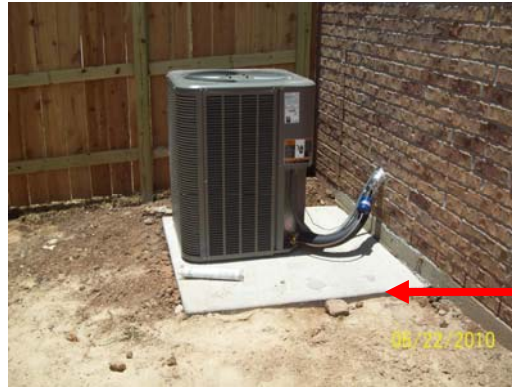
The unit did not have the required 3" clearance from grade.

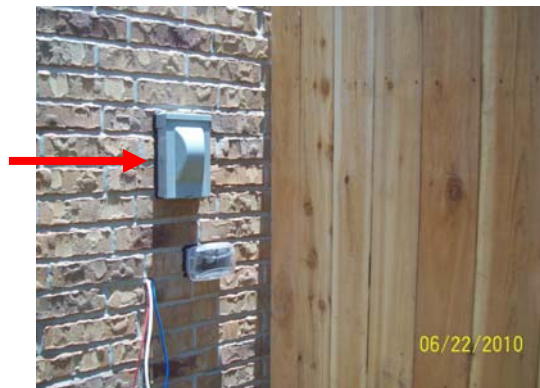
The condenser's disconnect switch was located on the outside of the wood fence and not in the direct line of site from the condenser.

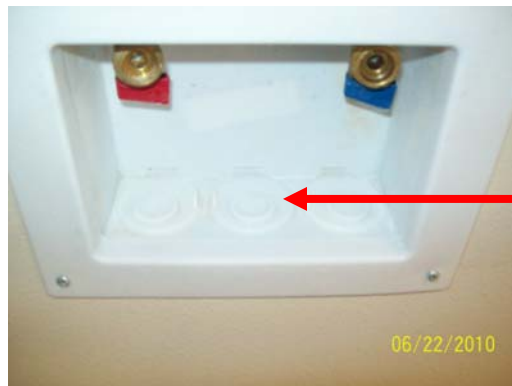
Drain/water lines for the washing machine were not inspected due to the drain access not being accessible.

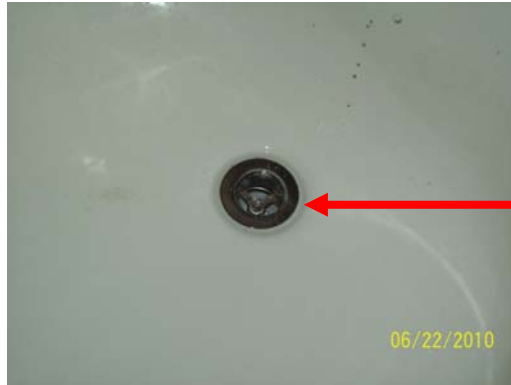
No drain stops installed in bath tubs.

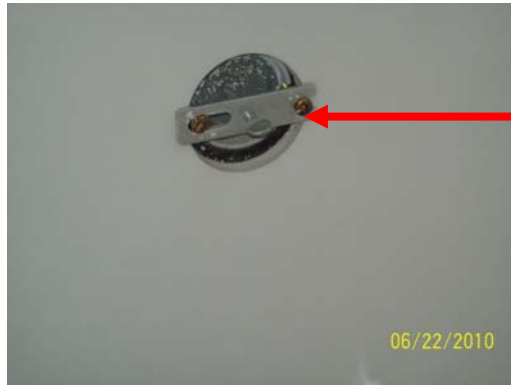
Master bath tub is missing the overflow drain cover plate.

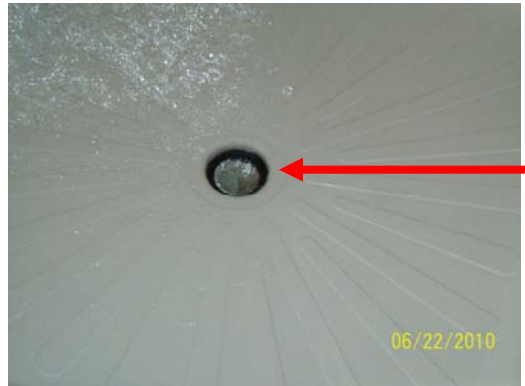
Master shower drain is missing the drain cover.

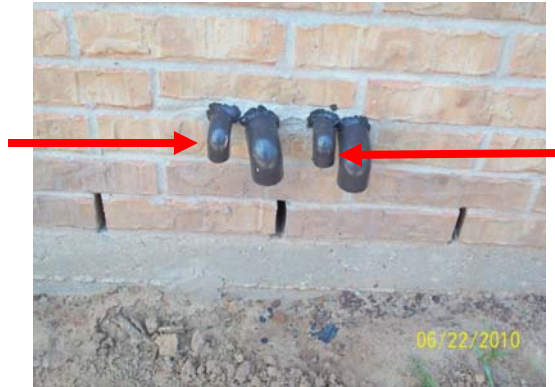
TPR Valve drain lines no not terminate within 6" to grade.
