American Property Inspections of Texas

PROPERTY INSPECTION REPORT

Concerning: 1234 Sample Dr. Anytown, TX.

August 3, 2010

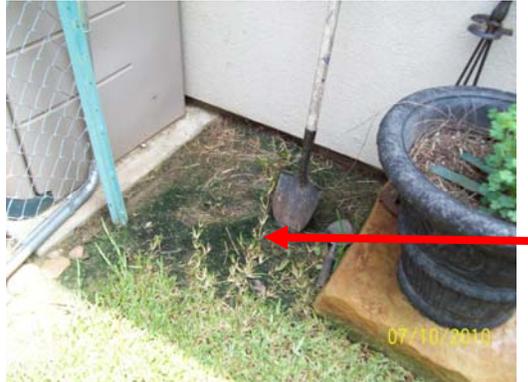
Some areas around the foundation showed signs of erosion and possible locations for ponding.

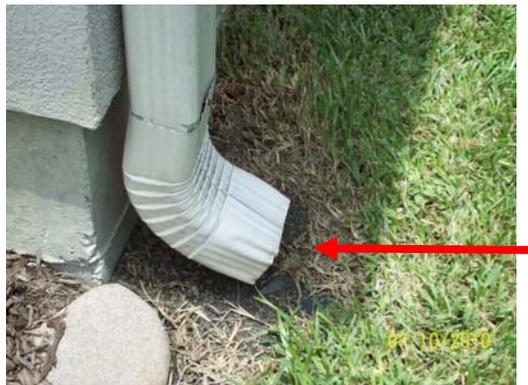
Gutter down spouts do not divert water from foundation properly, down spouts should divert water away approximately 5' from foundation.

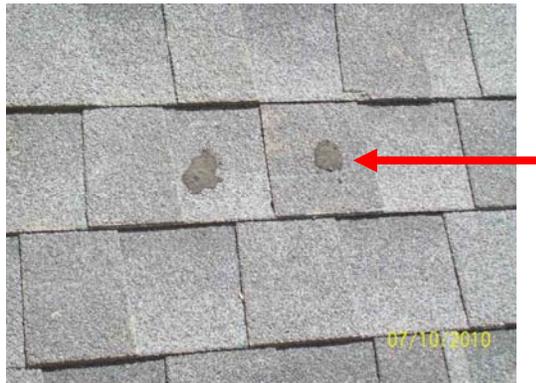
Roof showed signs of previous repairs. Exposed nail heads and nails popping out at various locations and damaged/missing shingles at various locations.

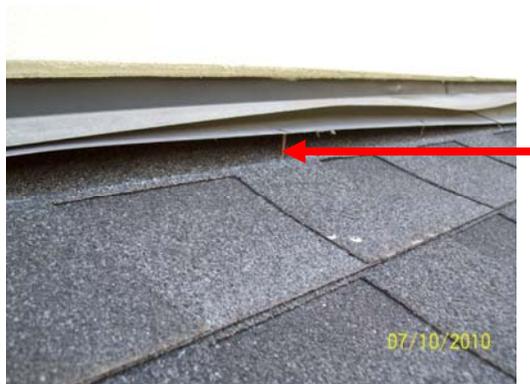
Flashing on the south and east side needs to be nailed down and sealed.

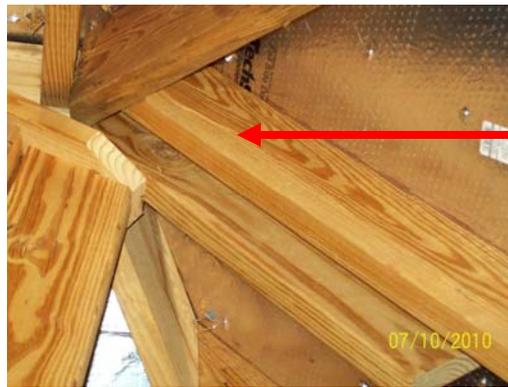
Cracked rafter in attic.

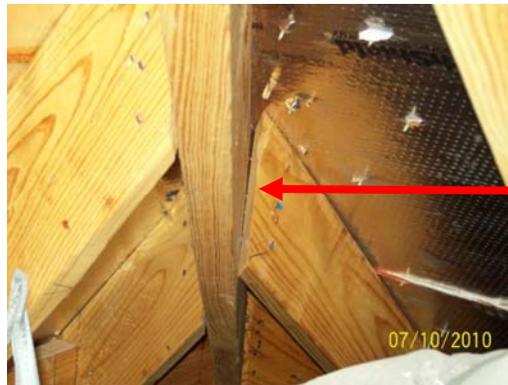
Cut line for rafter at hip ridge board is not cut properly.

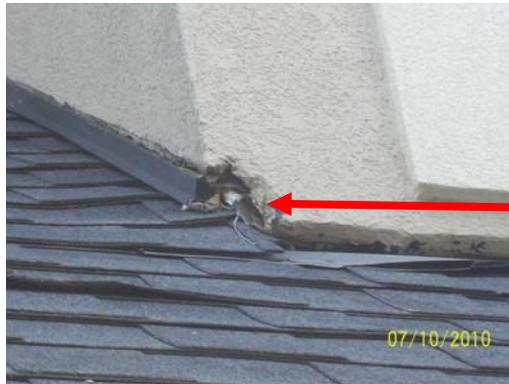
Damage to wall on the west side.

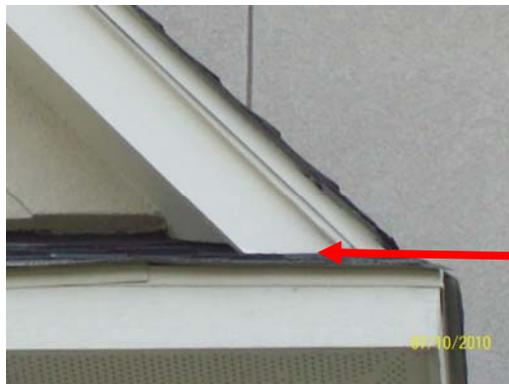
Exterior walls should be cut back a minimum of 2" where the wall meets the roof line.

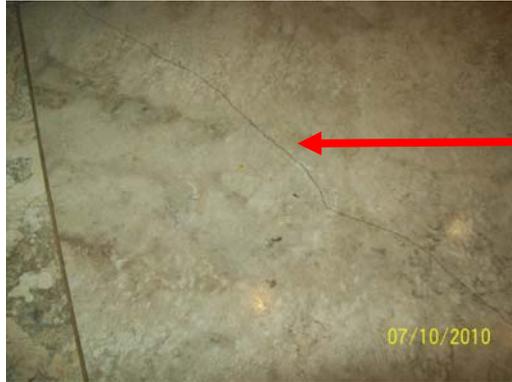
Cracked floor tile in kitchen.

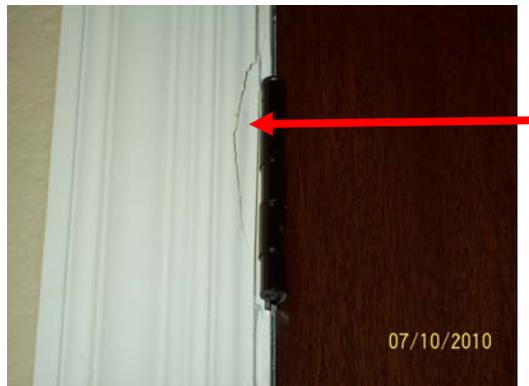
- Front and rear door dead bolt needs to be replaced with a dead bolt that can unlocked without the use of a key or special knowledge or effort.
- Front door is not properly sealed when shut.
- Front door frame trim is cracked.

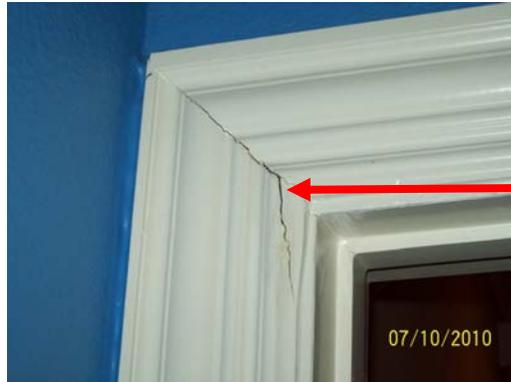
Door frame in northeast bedroom is cracked.

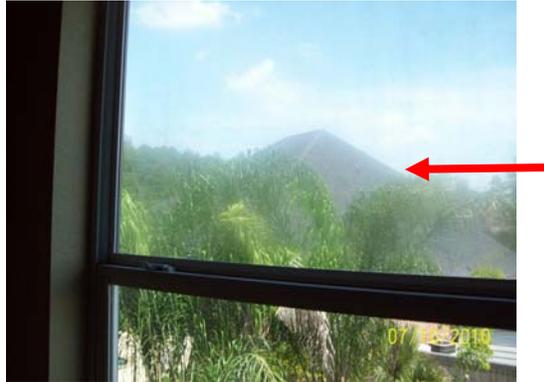
Double pane window in Gym appears to have a broken seal.

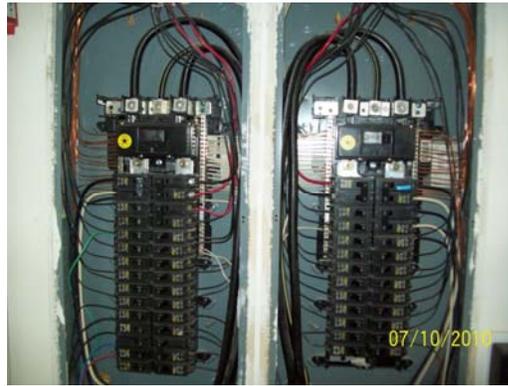
Double tapping of grounding conductors at bus bar.

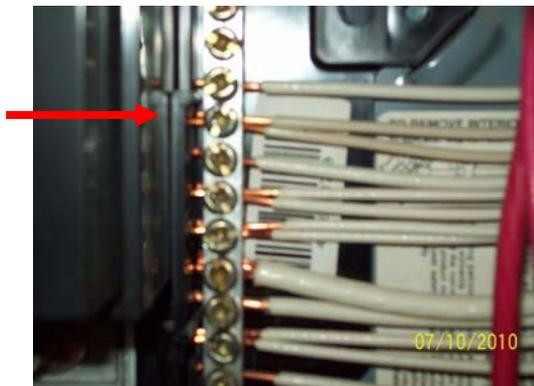
No anti-oxidizing compound on aluminum feeder wires.

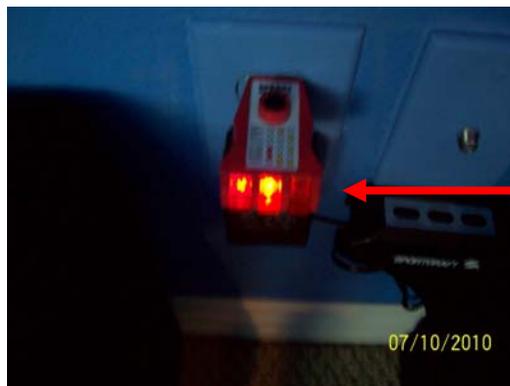
The receptacle in the northeast bedroom on the south wall has reversed hot and neutral wires.

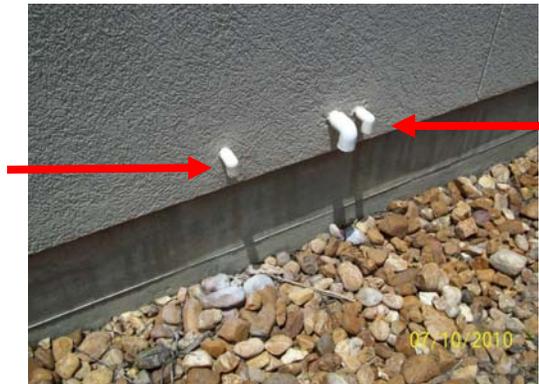
TPR Valve drain lines did not terminate within 6" of grade.
