PROPERTY INSPECTION REPORT

Concerning: 1234 Sample Rd. Anytown, USA

By: **Rod Scarborough** TREC License # 7189

July 22, 2010

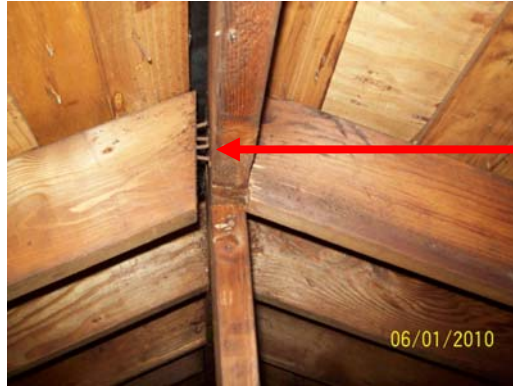
Separation of rafters at ridge beam in attic.

There were some signs of differential movement as noted by separation of rafters at the ridge beam at cracked rafters at various location.

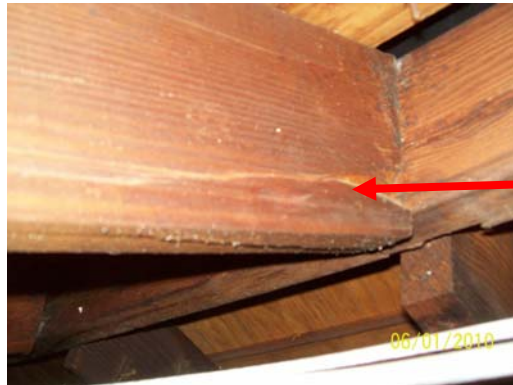
Cracked rafters in attic.

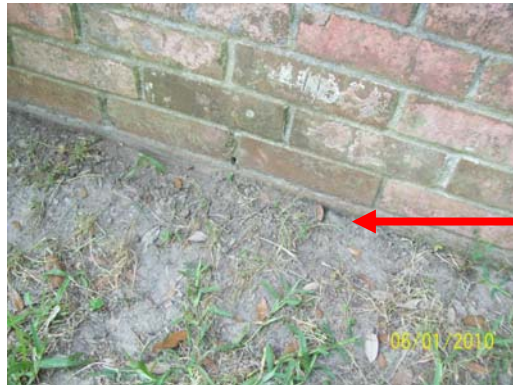
There were areas around the structure that were not accessible due to improper grade clearances/stored items around structure.

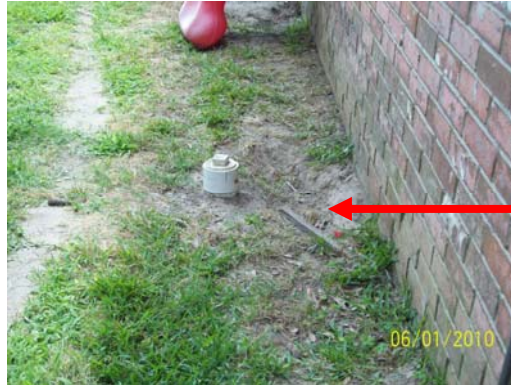
Some areas around the foundation showed signs of erosion and possible locations for ponding.

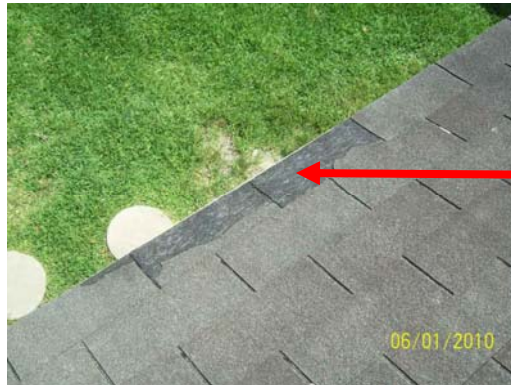
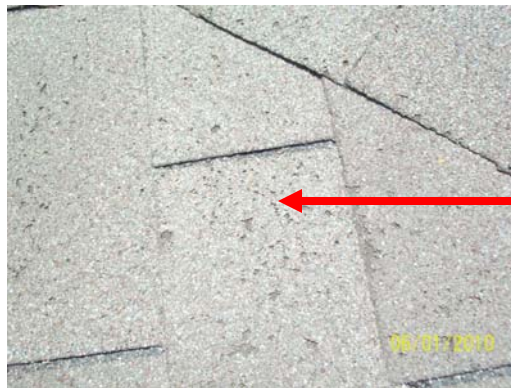
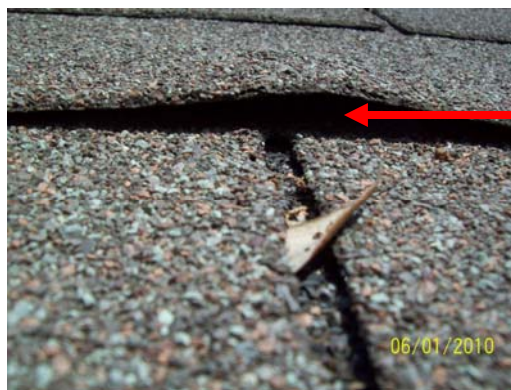
Damaged/missing shingles, nails popping out, drip edge missing and exposed nail heads.

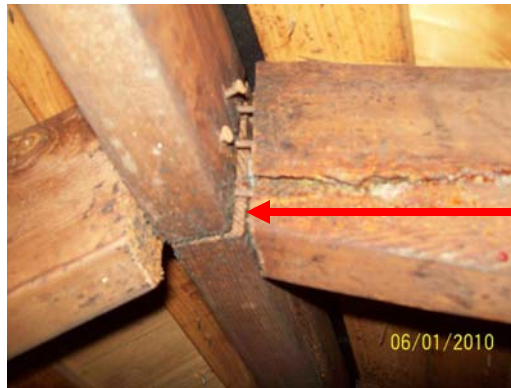
Splice in ridge beam not properly supported.

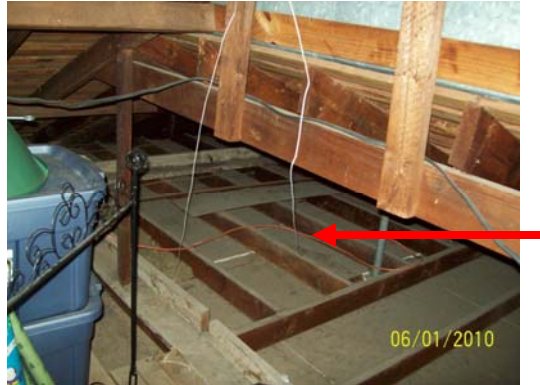
No fire wall installed in the attic between the garage and living space.

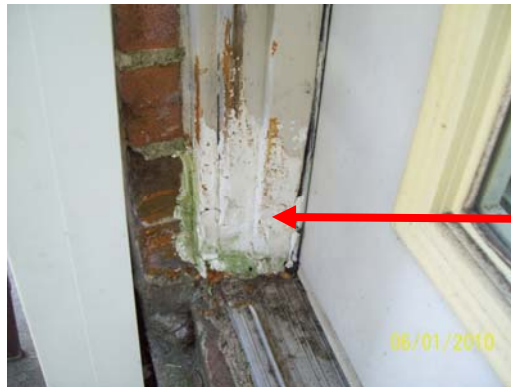
Minor damage to siding/trim at various locations around structure.

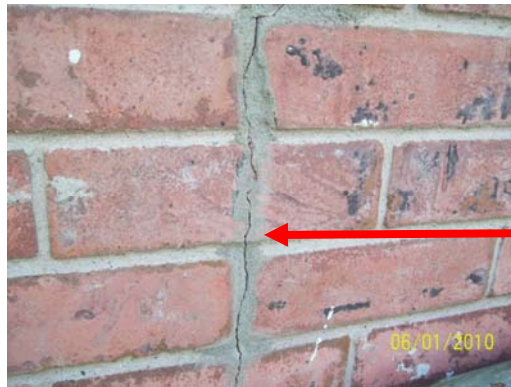
Brick cracks/repairs at various locations around structure.

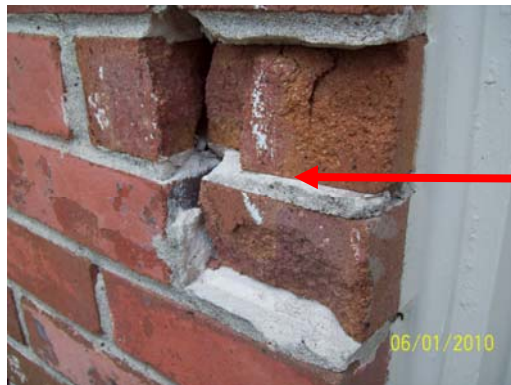
Brick damaged and loose to the left side of the garage doors.

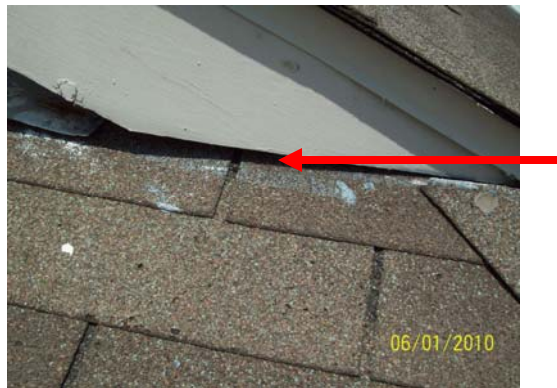
Exterior walls should be cut back a minimum of 2" where the wall meets the roof line.

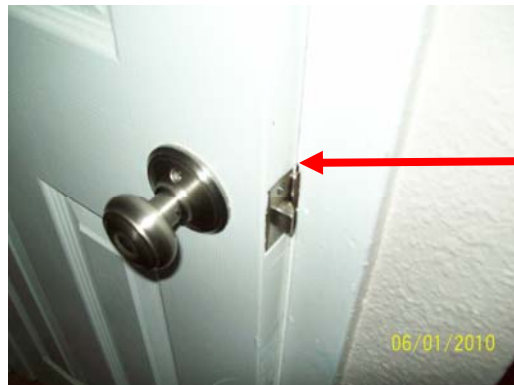
Door to the hall closet would not close, is hitting the door trim.

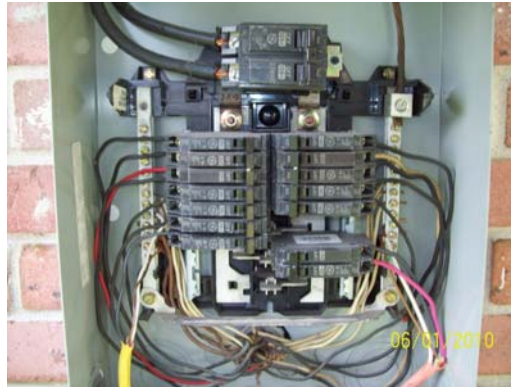
The dead front was removed and the interior of the panel was inspected.

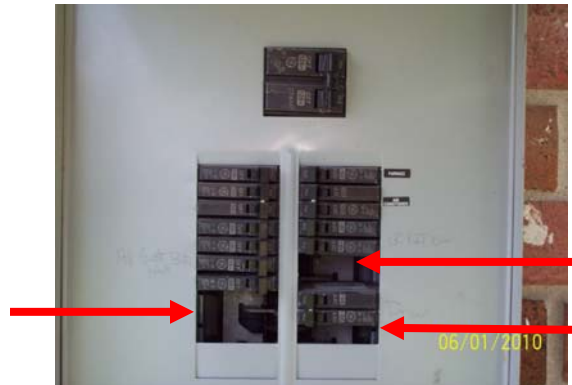
Panel not properly labeled and knockouts are missing.

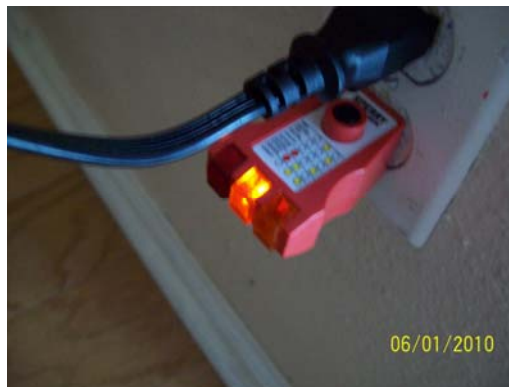
Appeared to be functioning as intended however there were some receptacles that had open grounds in the garage, living room and master bedroom.

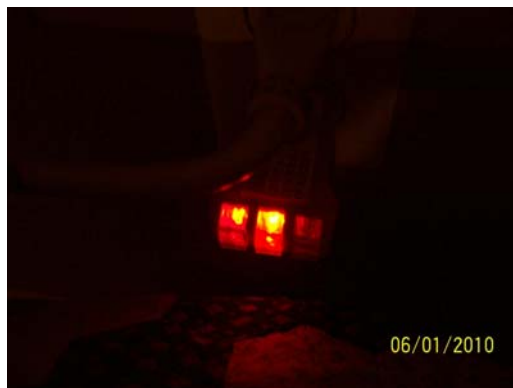
- Some of the light fixtures did not function.
- Receptacle in the master bedroom on the east wall has reverse polarity.

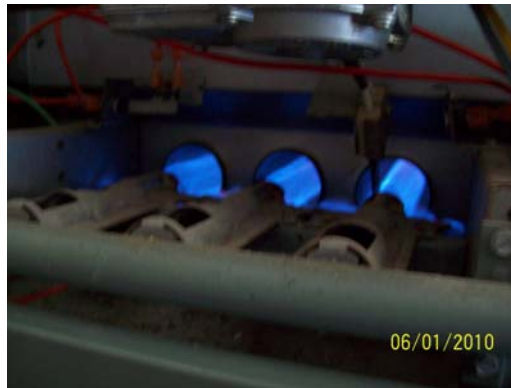
Unit was operated and appeared to be functioning as intended. A thermal reading was performed and ranged from 980degrees to 109 degrees.

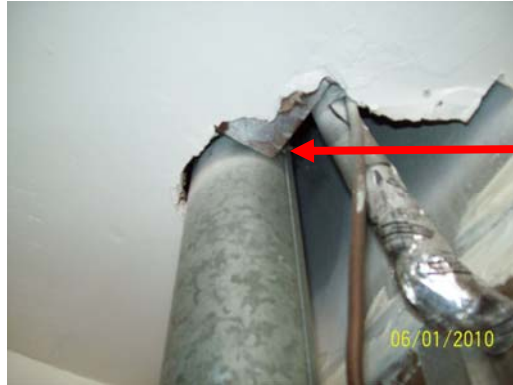
Heater flue vent to close to combustibles, should be a minimum of 2" clearance.

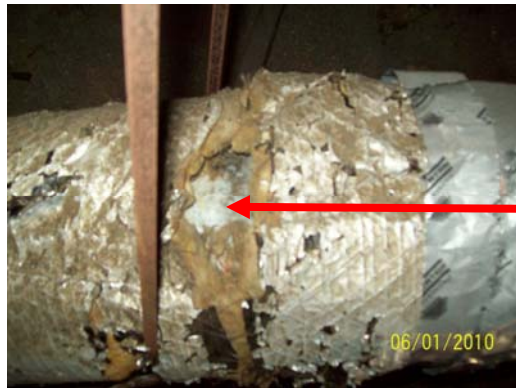
Insulation on the metal ducts was damaged and showed signs of aging and was damaged at various location.

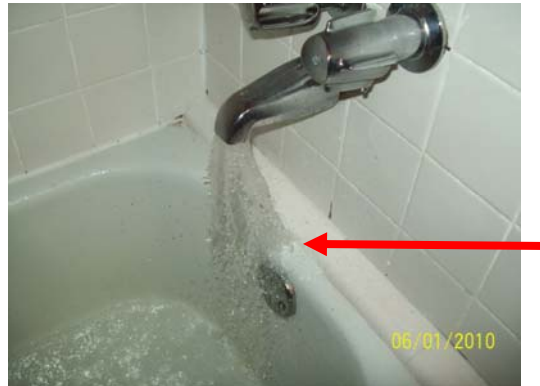
which resulted in water being sprayed onto the floor and walls.

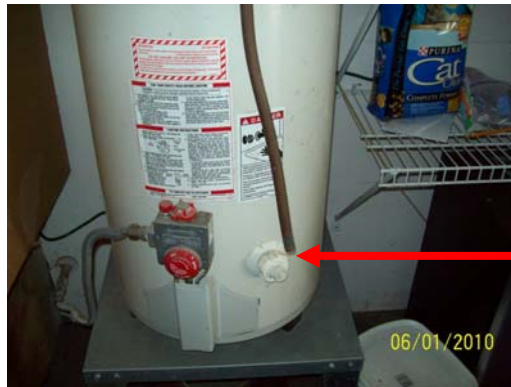
TPR Valve did not terminate in a safe location and did not terminate within 6" to grade.

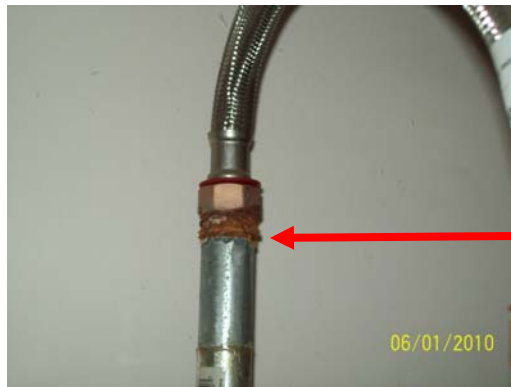
Oxidation of the two differing metal on the hot water supply side.

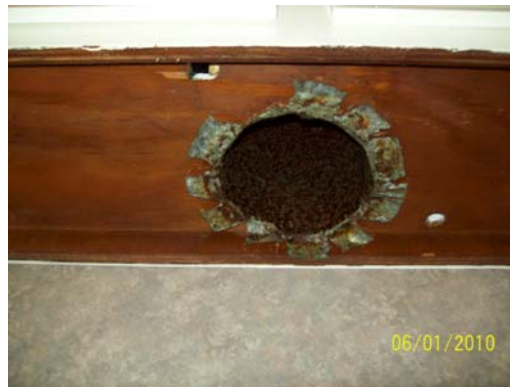
Comments:
 Not installed.
