## PROPERTY INSPECTION REPORT

Concerning: 1414 ABC Houston, TX.

Inspected By: Rod Scarborough TREC License # 7189 July 27, 2011

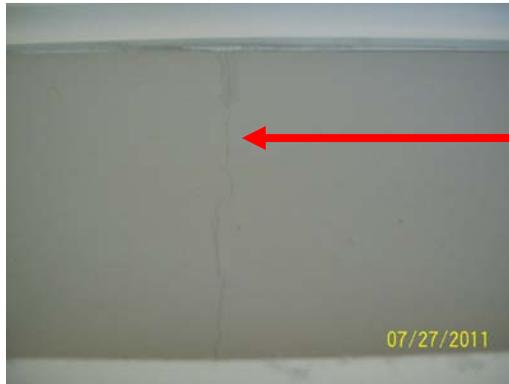
Hairline vertical cracks were observed but may not be limited to the master bedroom & kitchen areas above windows/doors on the interior of the structure. These should be repaired and monitored on a continual basis for future movement.

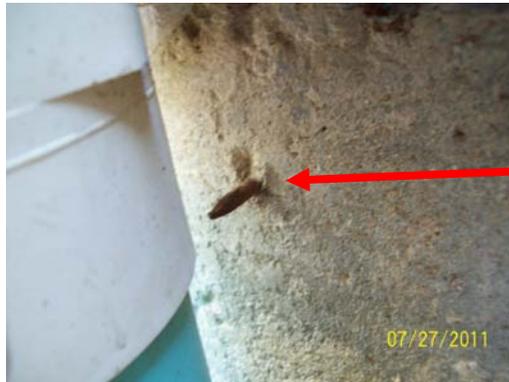
Exposed nails were observed but may not be limited to the east & west sides of the structure. These should be removed/sealed and monitored on a continual basis.

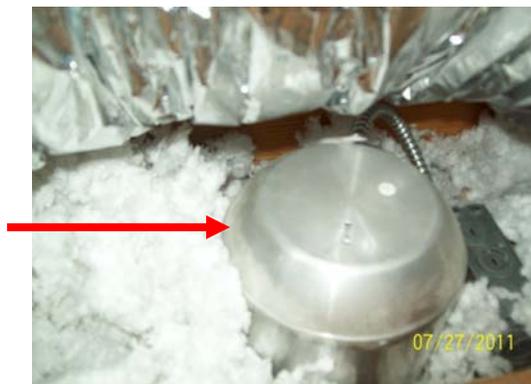
Insulation was observed within 3" of recessed light fixtures. Insulation should be maintained a minimum of 3 inches and wood a minimum of 1 inch from around all recessed fixtures to reduce possible fire hazard. Exception: when lights are listed and labeled as IC (insulation contact) they may be in contact with insulation. No such label was observed.

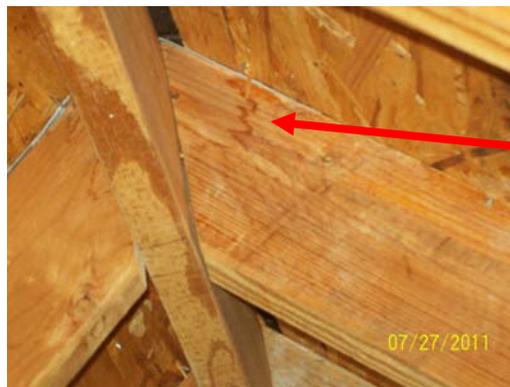
Existing/previous moisture penetration was observed on the rafter near the ridge beam.

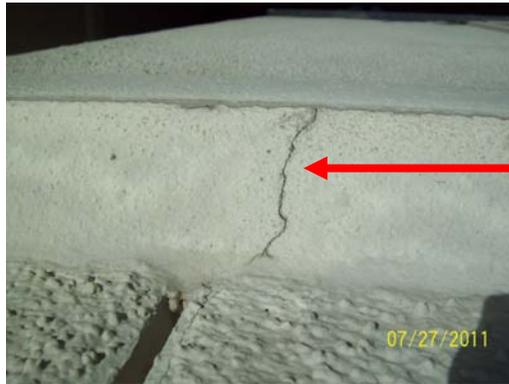
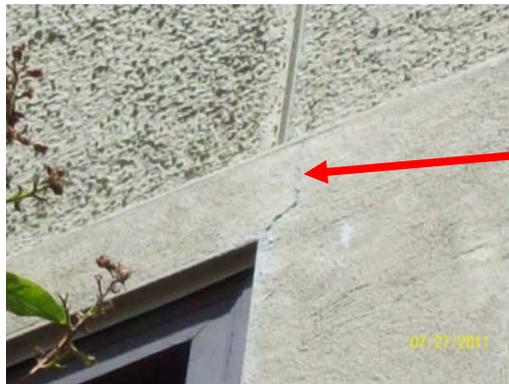
Hairline cracks to stucco finish coat was observed at various locations on the north & south sides of the structure. This should be repaired/sealed to prevent possible moisture penetration and monitored on a continual basis.

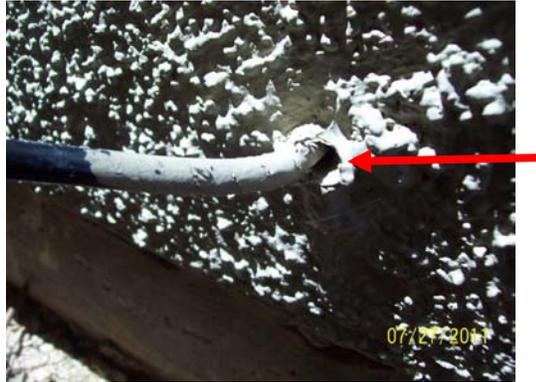
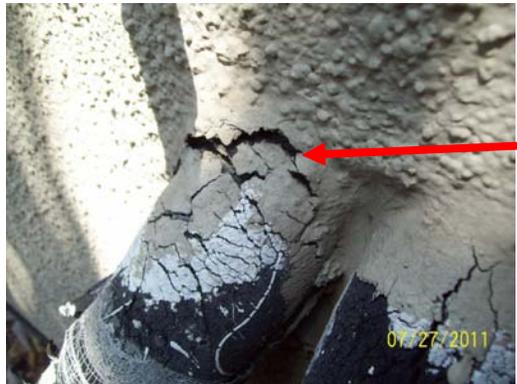
Exterior penetrations on the east and south sides of the structure should be properly sealed to prevent possible moisture penetration.

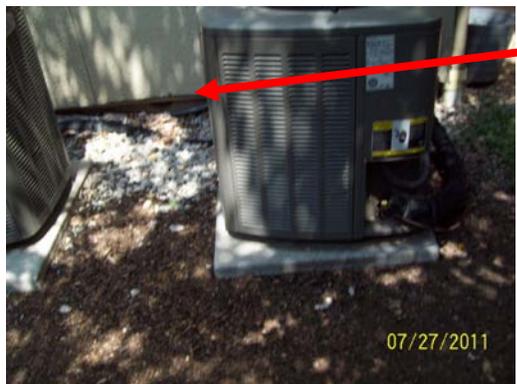
Stucco finish does not have the 8" clearance from grade in some areas around the structure.

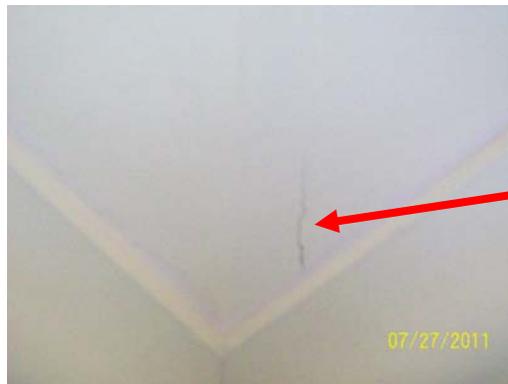
Cracking was observed but may not be limited to the master bedroom on the interior of the structure. This should be repaired and monitored on a continual basis.

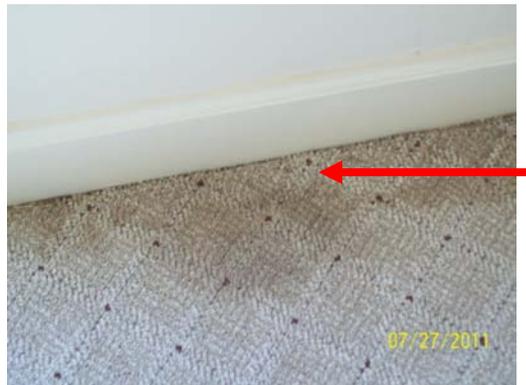
What appeared to be existing/previous moisture penetration was observed but may not be limited to the wall/flooring in the downstairs south bedroom on the interior of the structure. This should be repaired and monitored on a

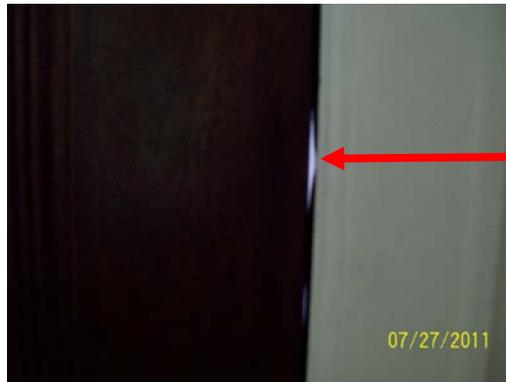
The front door does not properly seal when closed and the door hardware is loose.

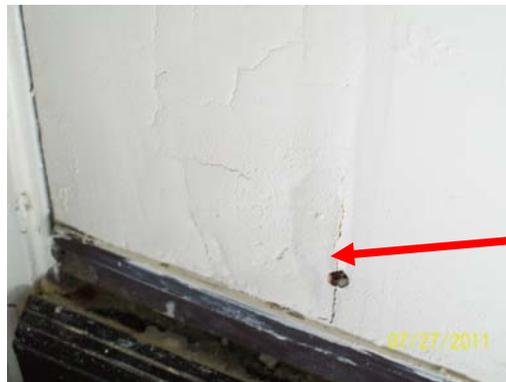
Damaged/rotted door was observed at the door in the down stairs bedroom leading to the backyard.

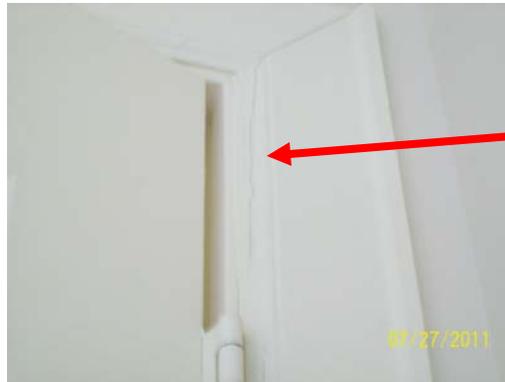
Door trim leading into the east bedroom on the 1st floor cracked.

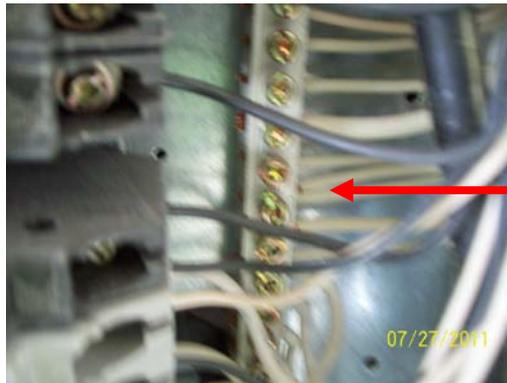
Double tapping of neutral conductors at bus bar.

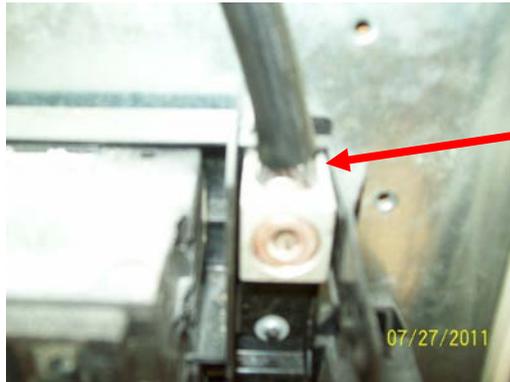
No anti-oxidizing compound on aluminum feeder wires.

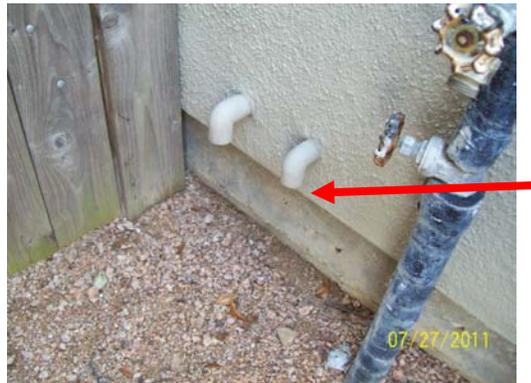
What appeared to be the TPR Valve drain line does not terminate within 6" to grade. TPR Valve drain lines should terminate within 6" to grade and in a safe location to prevent the possibility of injury in the event the TPR Valve were to discharge.

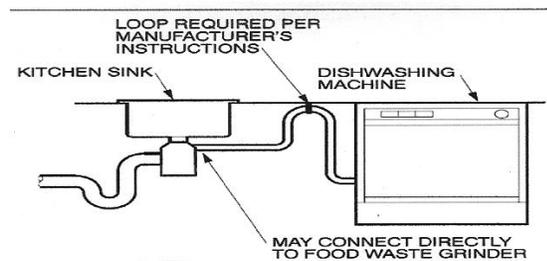
Air gap in the dishwasher drainpipe is not installed, when installed properly the air gap prevents the potential backflow of contaminants from the disposer back into the dishwasher. The dishwasher drainpipe should be secured to the underside of the counter to create an upside down "U" in the drainpipe.

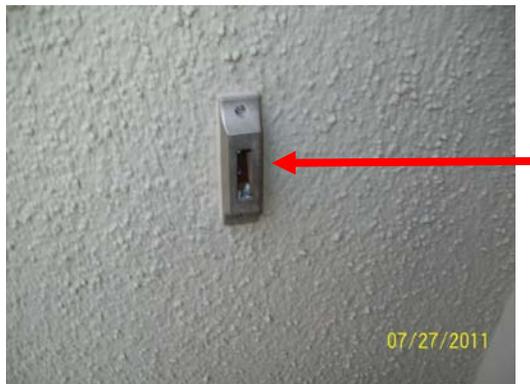
The door bell button at the front door is damaged and did not function as intended.
