# American Property Inspections of Texas

## PROPERTY INSPECTION REPORT

Concerning: 6013 ABC Houston, TX.

Inspected By: Rod Scarborough TREC License # 7189 September 3, 2011

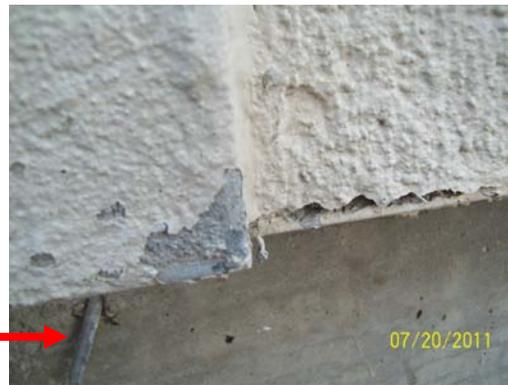
Exposed nail was observed but may not be limited to the north side of the structure. These should be sealed/removed and monitored on a continual basis.

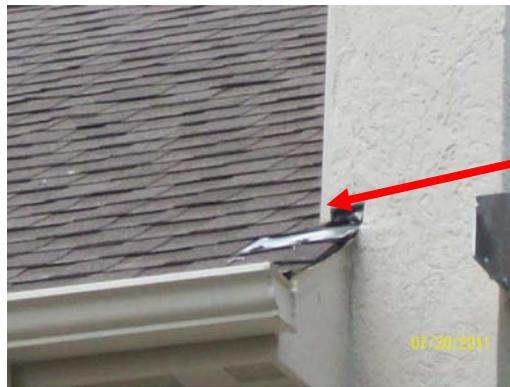
Kickout flashing did not appear to be installed at the northeast corner of the roof at the parapet wall. This should be added to divert water away from the wall.

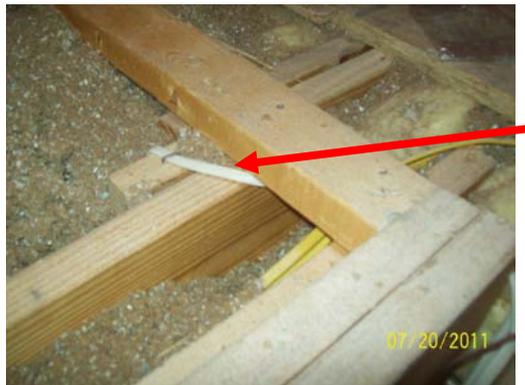
Electrical conductors are not protected within 6' of attic opening. Electrical conductors should be protected within 6' of the attic opening.

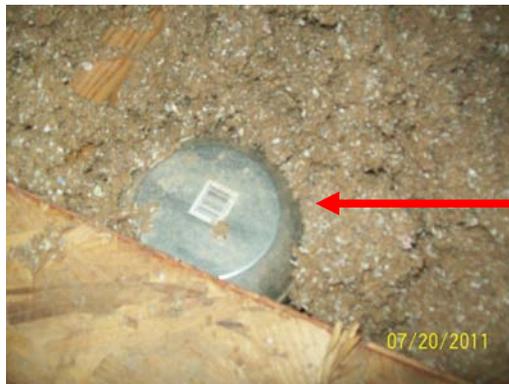
Insulation was observed within 3" of recessed light fixtures. Insulation should be maintained a minimum of 3 inches and wood a minimum of 1 inch from around all recessed fixtures to reduce possible fire hazard. Exception: when lights are listed and labeled as IC (insulation contact) they may be in contact with insulation. No such label was observed.

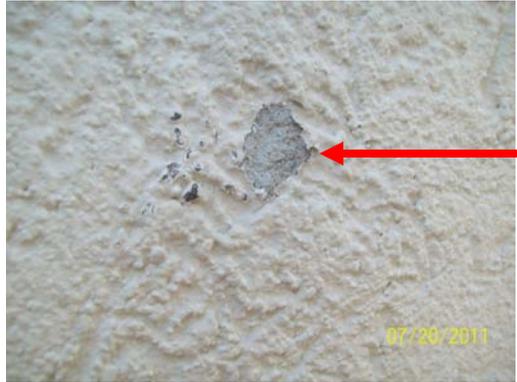
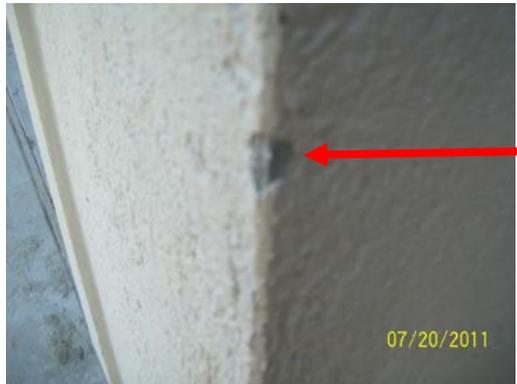
Damage to stucco finish coat was observed at various locations on the north side of the structure. This should be repaired and monitored on a continual basis.

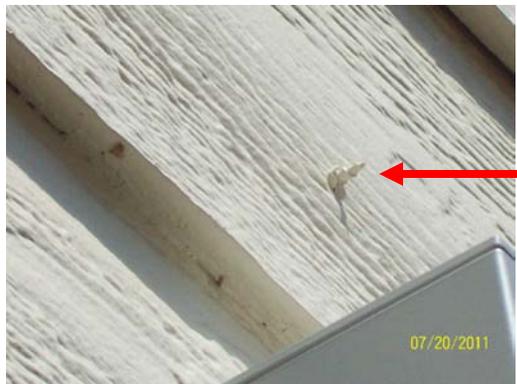
A screw head protruding through the cement board was observed but may not be limited to the area above the light fixture. This should be removed and properly sealed.

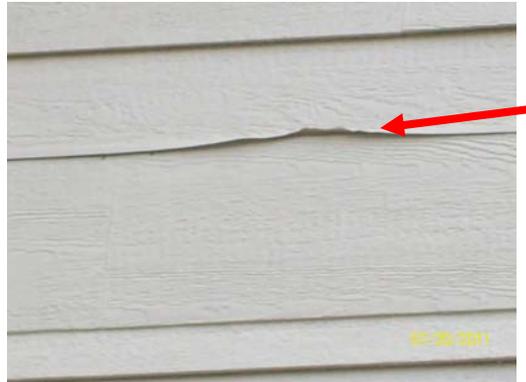
Z-Flashing on the south side of the structure is damaged. This should be repaired.

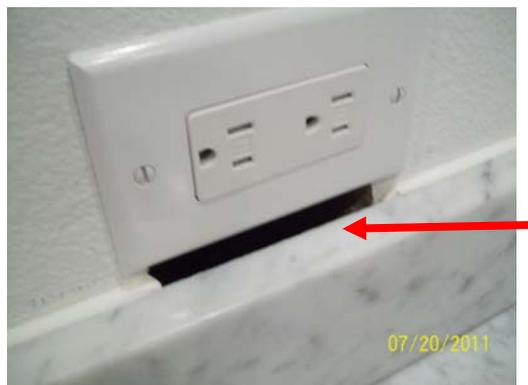
The opening below the receptacle to the left of the cook top in the kitchen needs to be properly sealed.

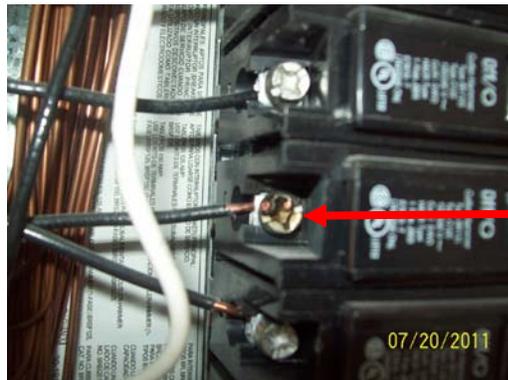
20 Amp breaker shows signs of what appeared to be overheating at the conductor connection/lug. This should be further evaluated by a qualified electrician.

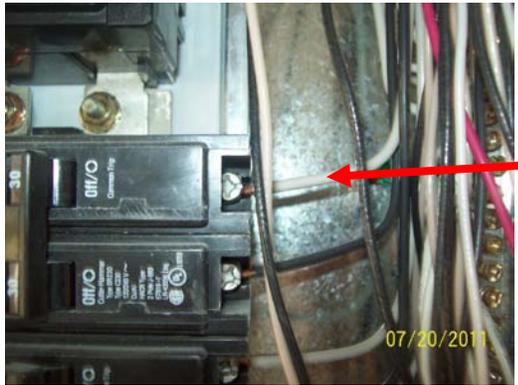
All "hot" wires on breakers should be red or black. Any other color wire should be painted or taped black to indicate that it is "hot". One or more white (neutral) wires are being used as hot wires without marking.

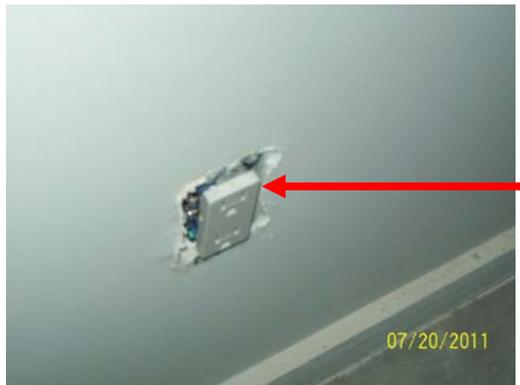
Missing cover plates were observed but may not be limited to the garage. These should be installed and monitored on a continual basis.

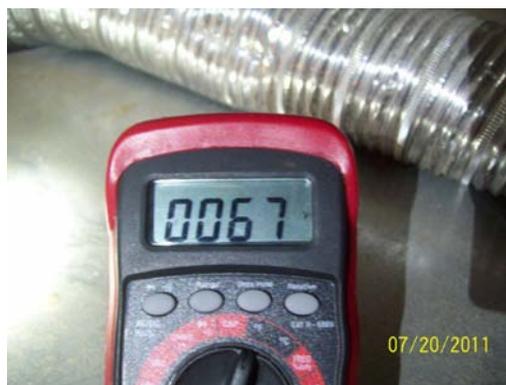
Supply air temp: 67 Degrees    Return air temp: 76 degrees (north unit)

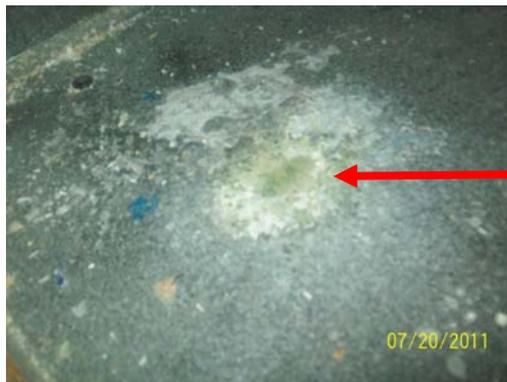
Condensation was observed in both of the secondary drain pans in the attic. Condensation was dripping from the insulation above the pans. This should be repaired and monitored on a continual basis.

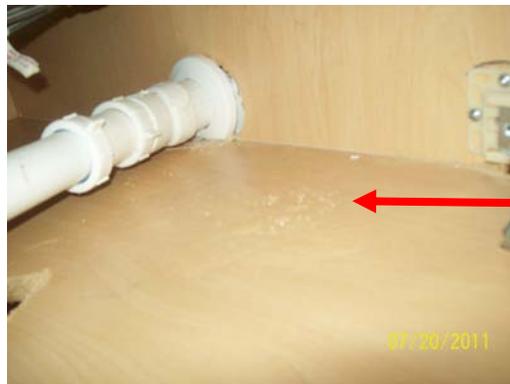
Active leak was observed under the left sink in the master bathroom. This should be repaired and should be monitored on a continual basis.
