# American Property Inspections of Texas

## PROPERTY INSPECTION REPORT

Concerning: 1234 Sample Court Anytown, TX.

**August 3, 2010**

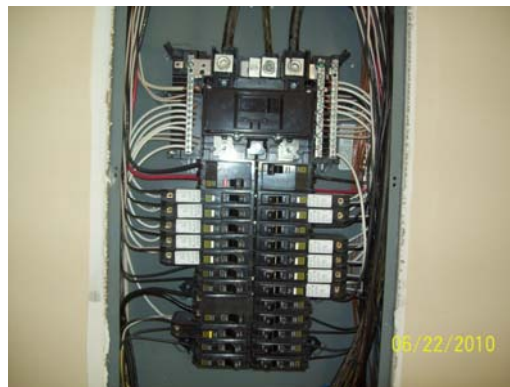
Panel appeared to be functioning as intended.

The dead front was removed and the interior of the panel was inspected.

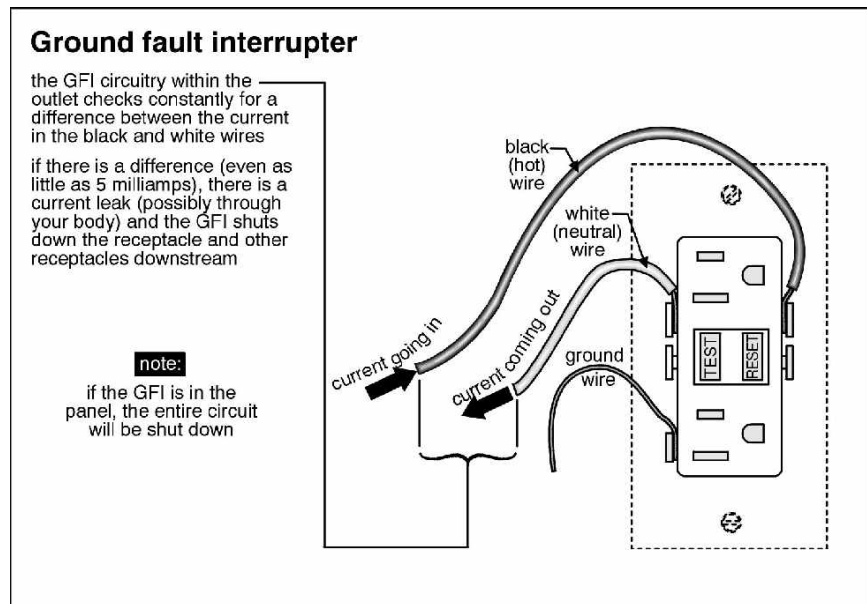
**Bathrooms:** Yes (GFCI located in upstairs and master baths)

**Garage:** Yes (GFCI located in garage)

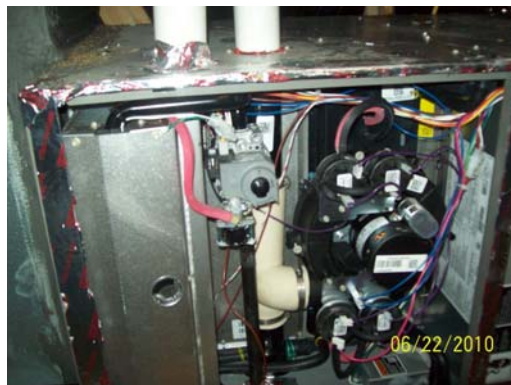
The unit was operated and appeared to be functioning as intended. A temperature reading was performed read 130 degrees at the supply side of the air handler.

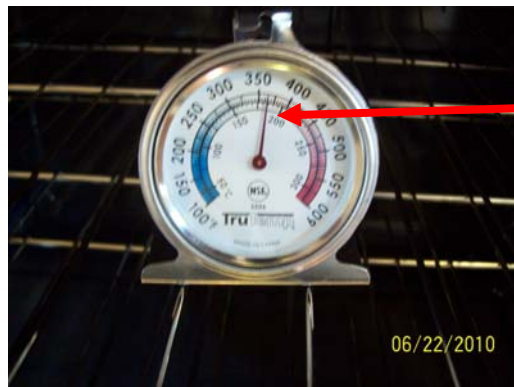
The unit was turned on to 350 degrees and allowed to cycle through the preheat function, a thermal reading was performed and read 365 degrees, a variance of 25 degrees is considered acceptable.
