# American Property Inspections of Texas

## PROPERTY INSPECTION REPORT

Concerning: 6013 ABC Houston, TX.

Inspected By: Rod Scarborough TREC License # 7189 September 3, 2011

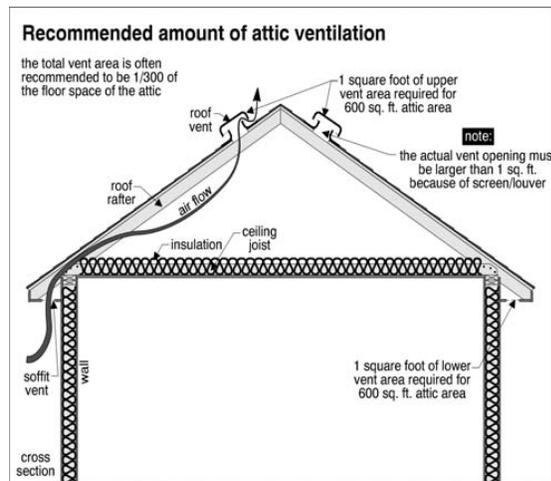
Roof structure/attic appeared to be stable and functioning as intended however there were deficiencies as described below.

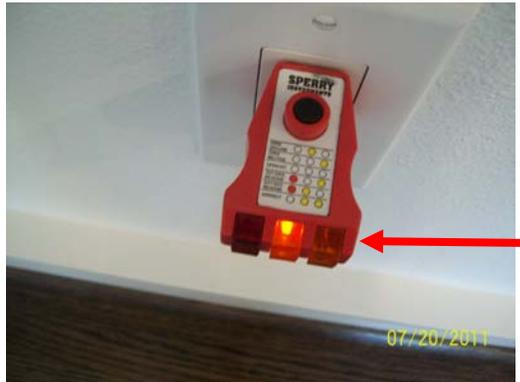
Missing cover plates were observed but may not be limited to the garage. These should be installed and monitored on a continual basis.

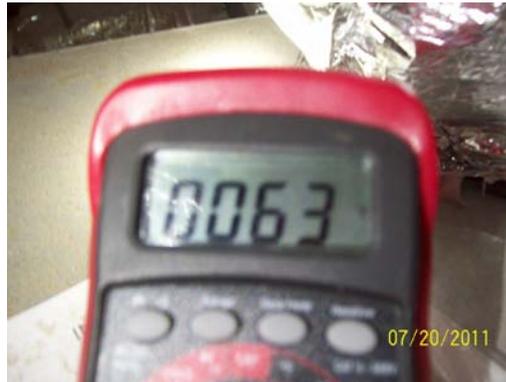
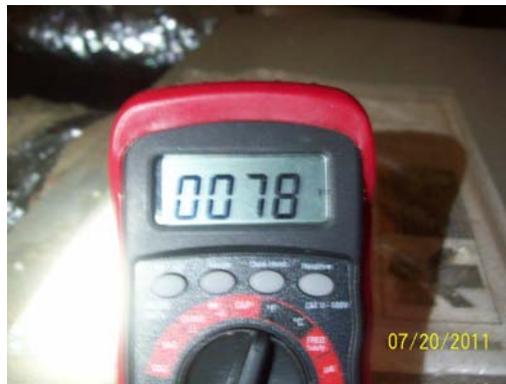
Supply air temp: 67 Degrees    Return air temp: 76 degrees (north unit)

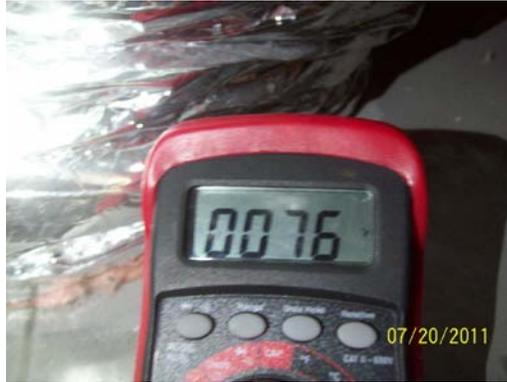
A variance of 15 - 20 degree between the supply and return air is considered to be functioning as intended.

The cooling equipment was operated and appeared to be functioning as intended however there were deficiencies as described below.
